## **Aircraft Accident Brief**

**EgyptAir Flight 990  
Boeing 767-366ER, SU-GAP  
60 Miles South of Nantucket, Massachusetts  
October 31, 1999**

**NTSB/AAB-02/01  
PB2002-910401  
Adopted March 13, 2002**

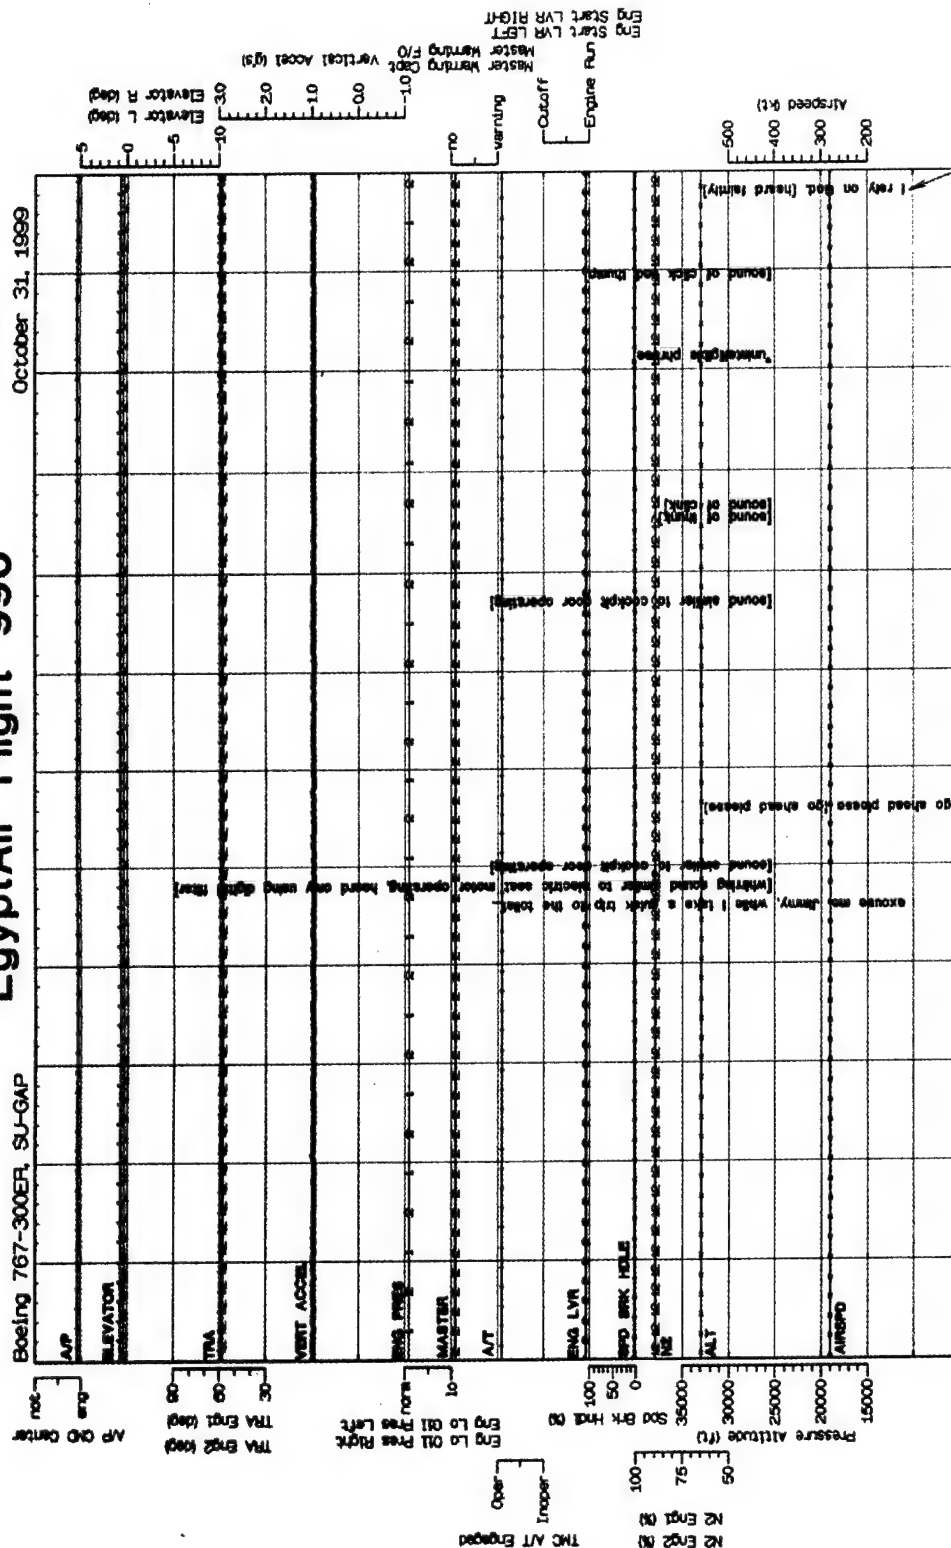
Figure 3a. A graph depicting selected FDR data from 1:47.40 to 1:48.40.

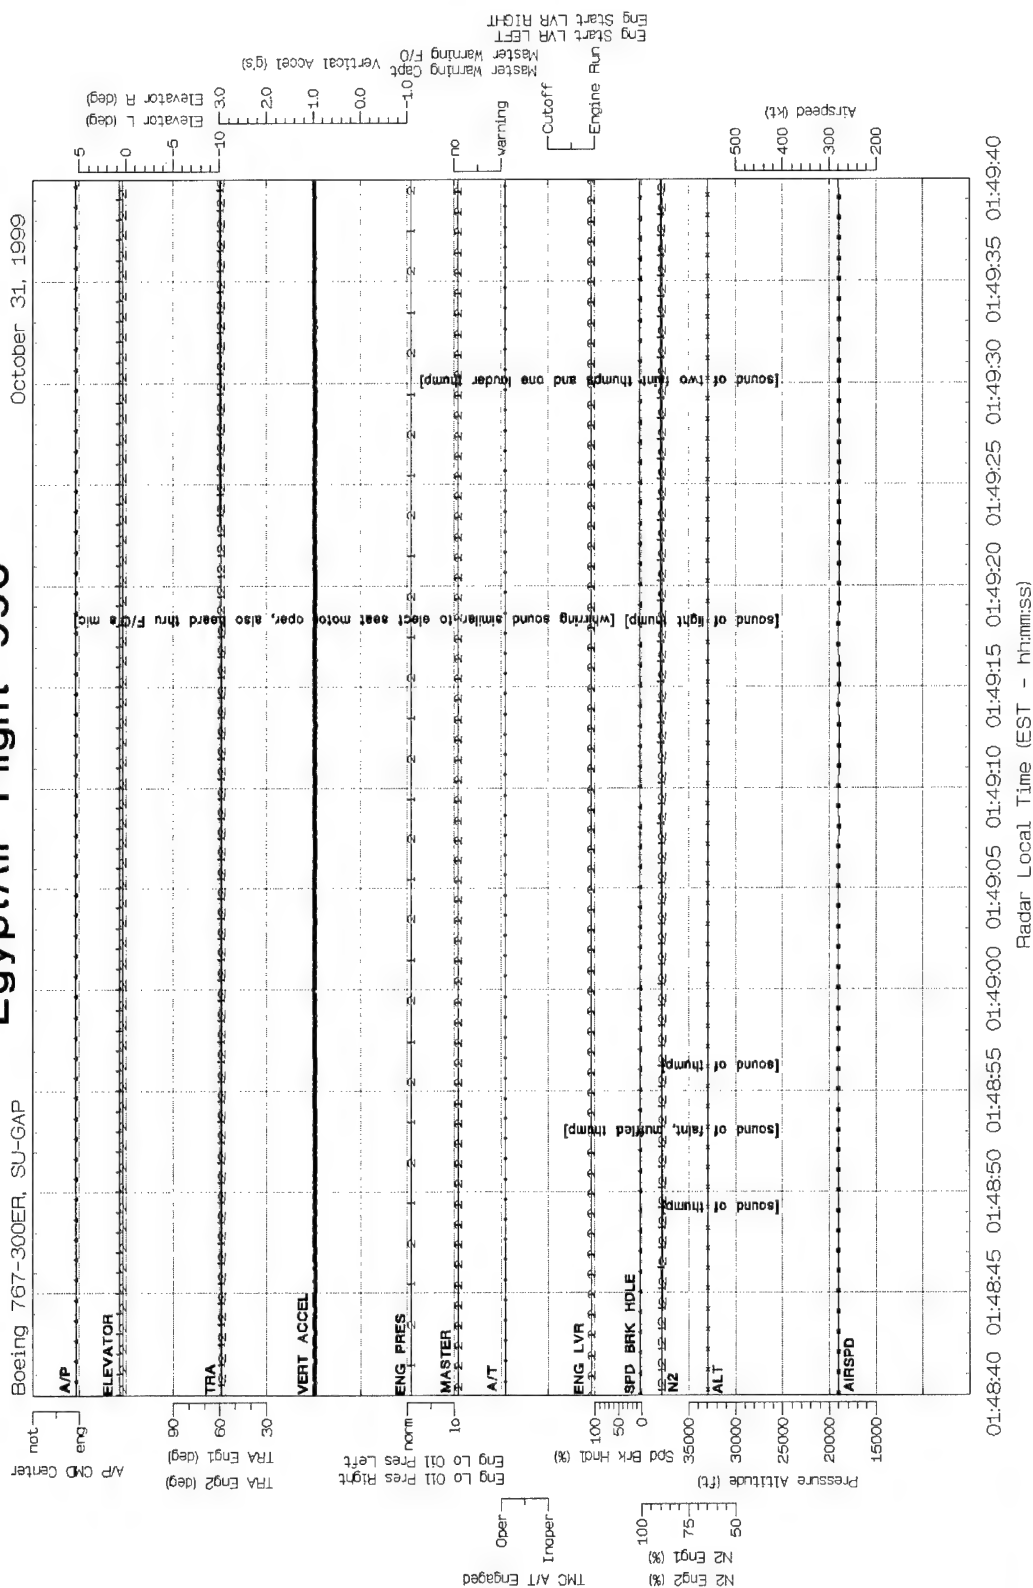
Figure 3b. A graph depicting selected FDR data from 1:48.40 to 1:49.40.

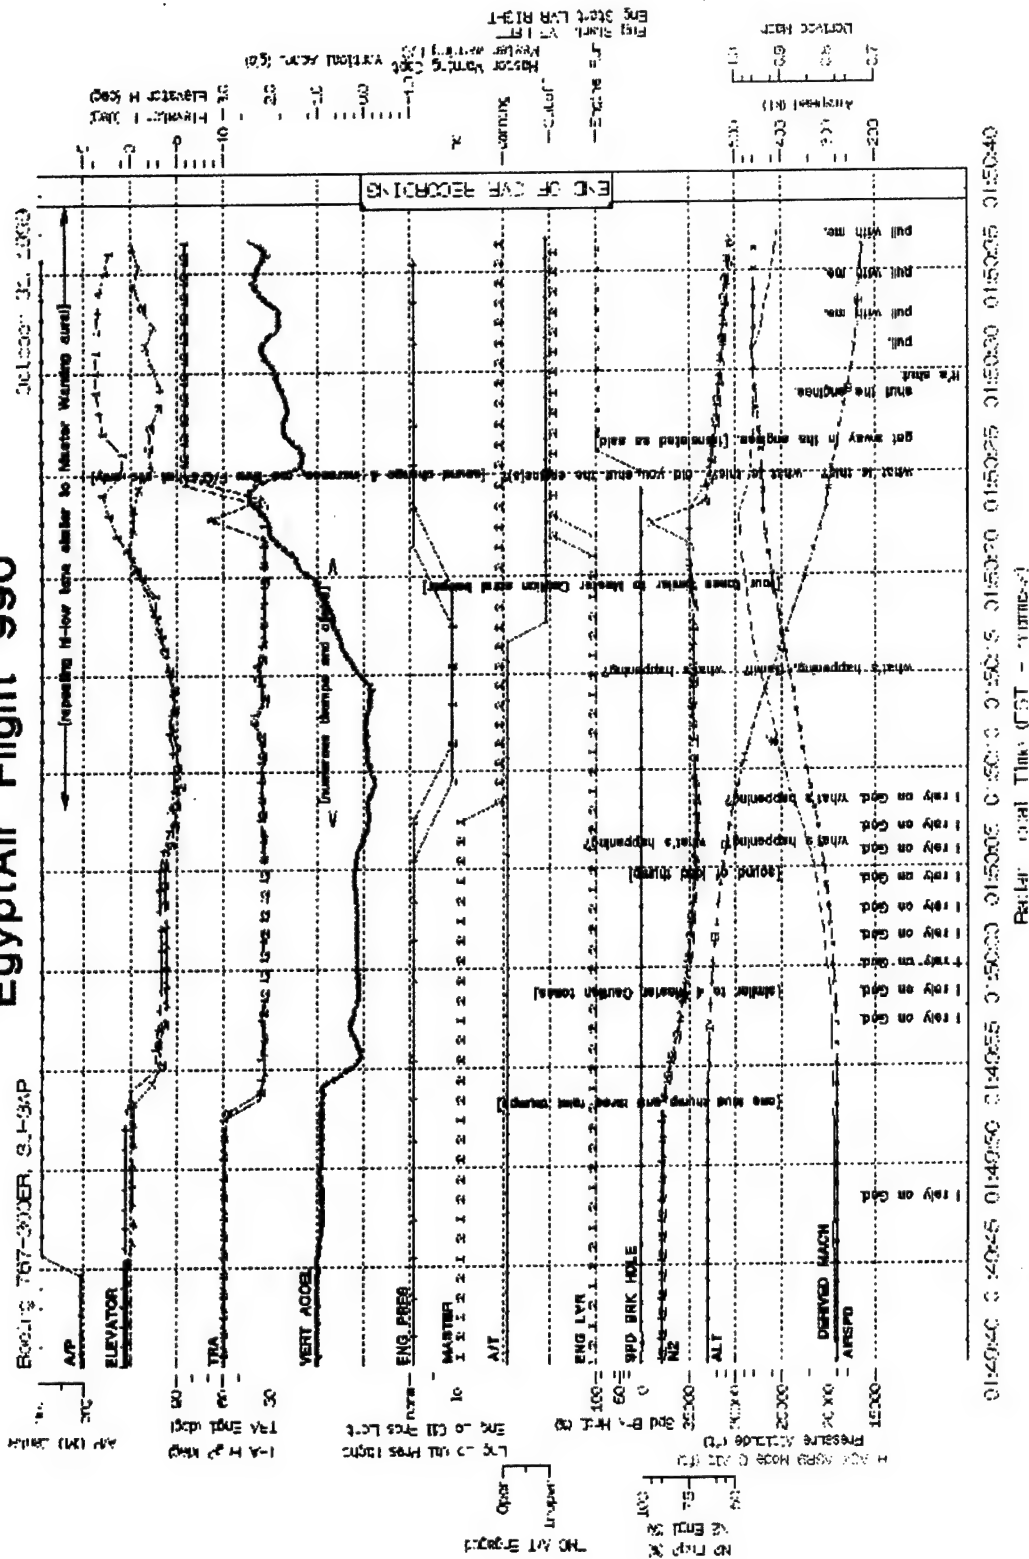
Figure 3c. A graph depicting selected FDR data from 1:49:40 to 1:50:40.

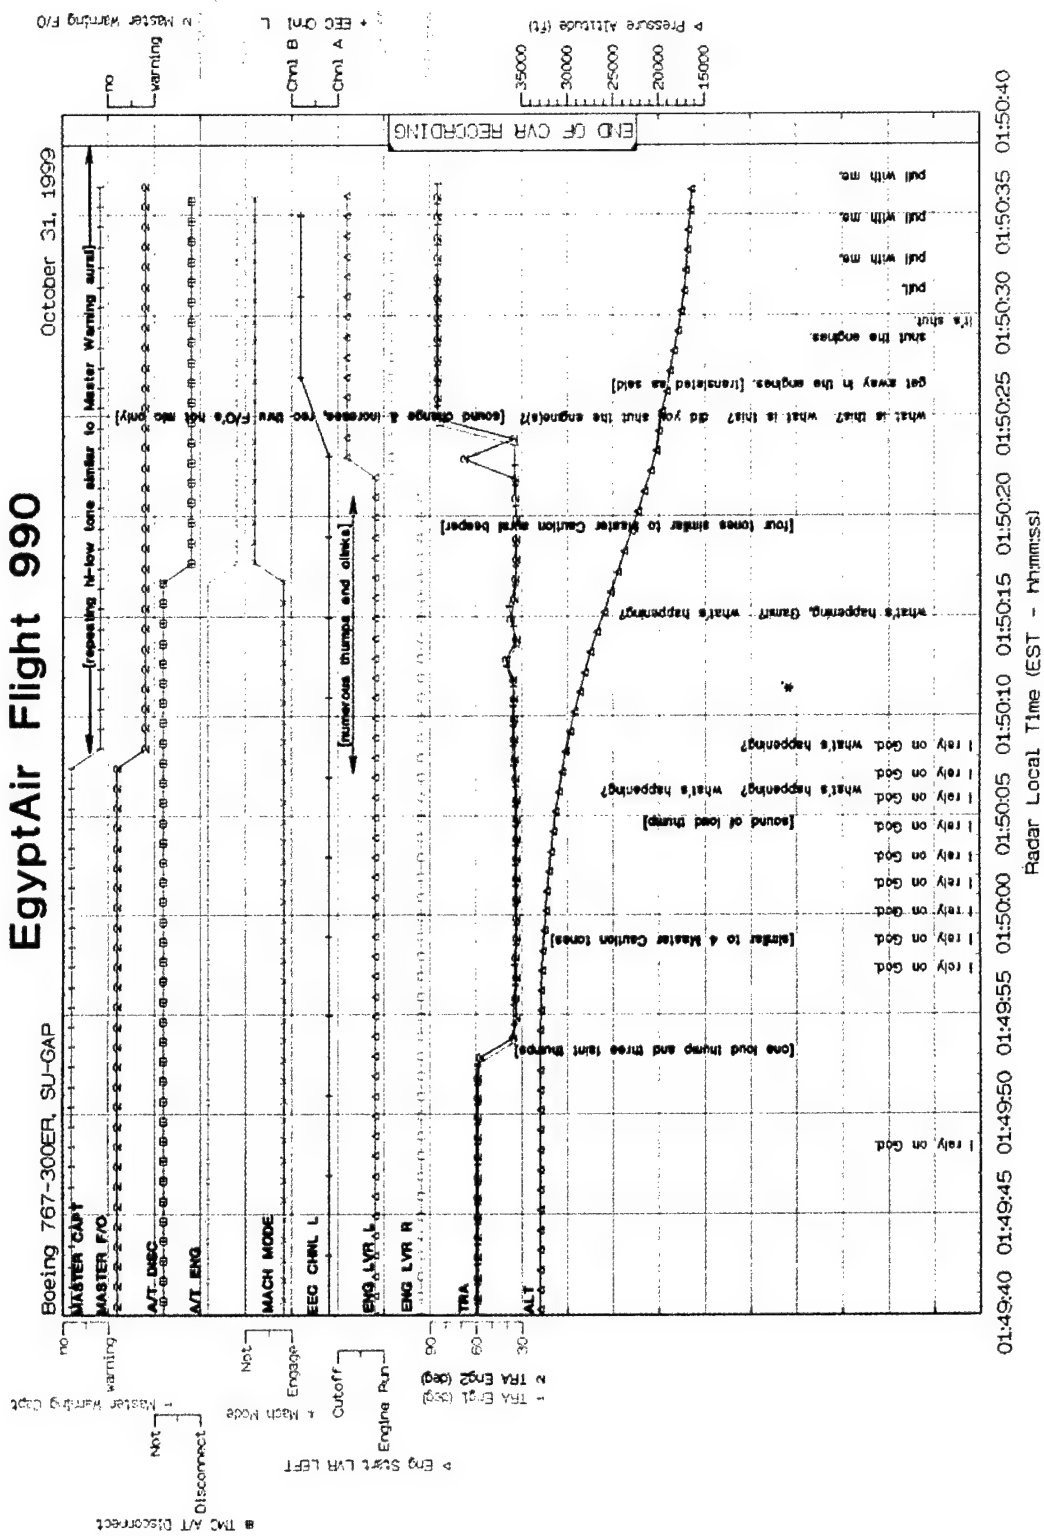
**Figure 3d.** A graph depicting selected FDR data from 1:49.40 to 1:50.40.

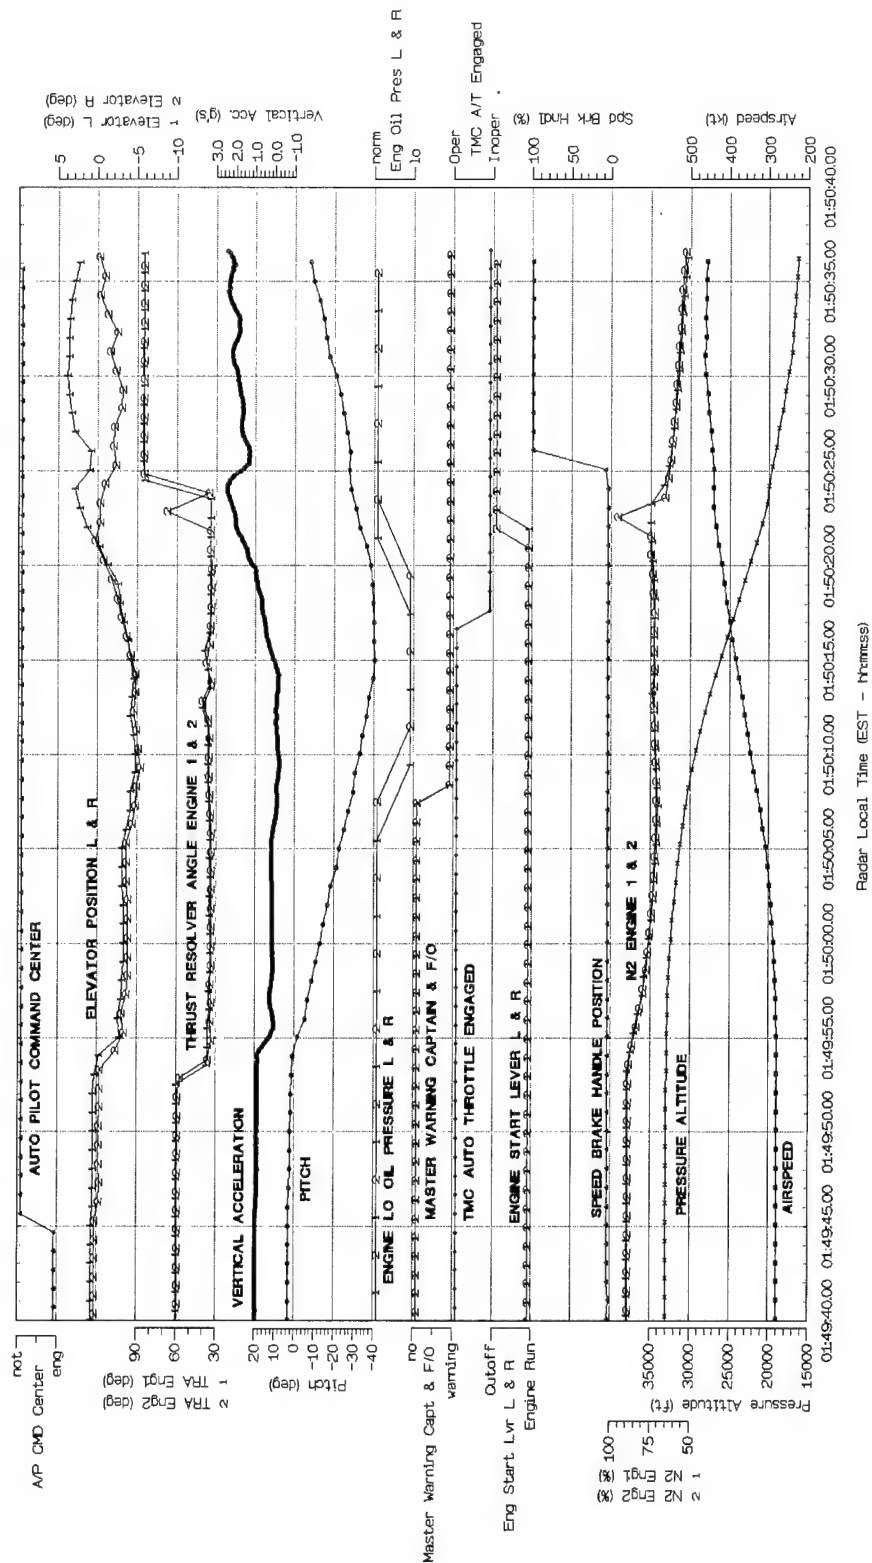
Figure 3h. A graph depicting selected FDR data from 1:49.40 to 1:50.40.

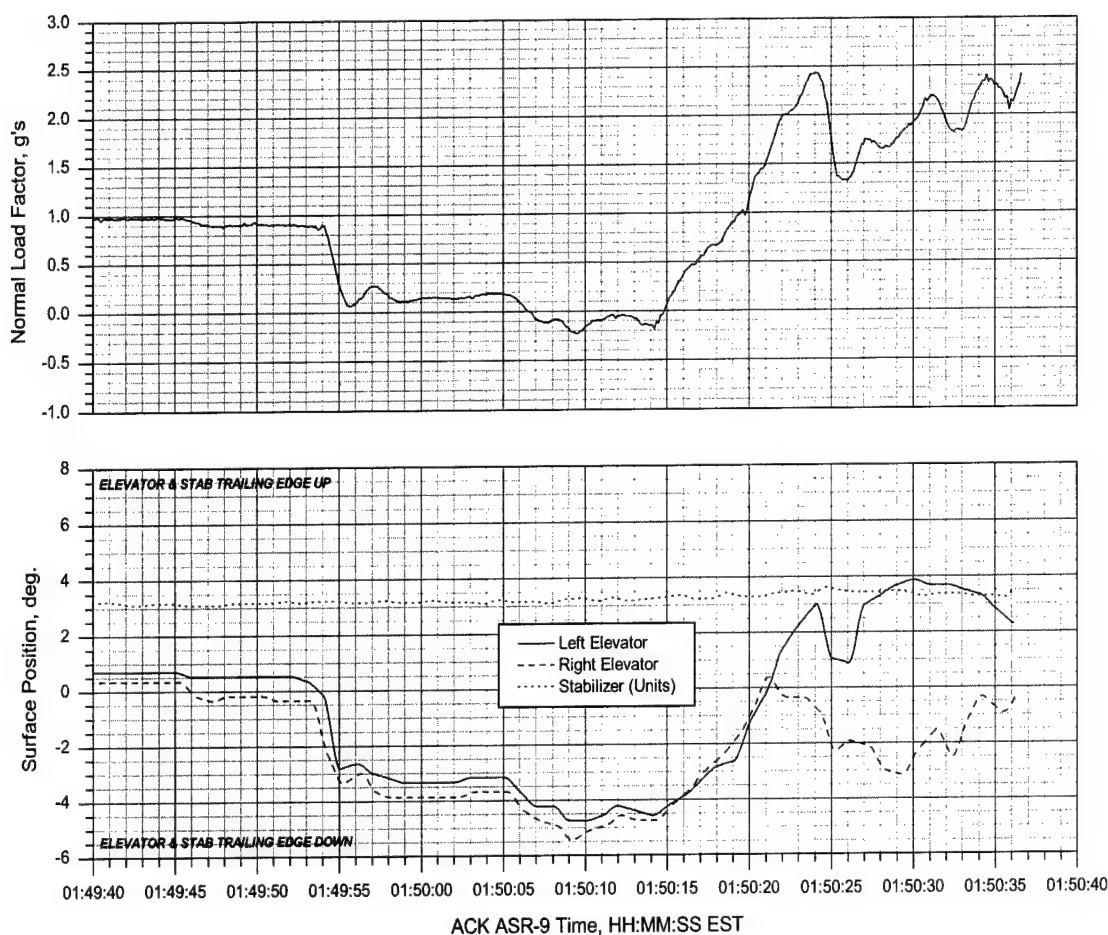
**Figure 4.** Graphs depicting the accident airplane's normal load factor response to elevator and stabilizer movement.
